Before and After: Winona Spring Wagon

High Country Horse Drawn LLC, Harlan and Joal Olson, Bozeman, MT 59715, (406) 548-2041 cell,

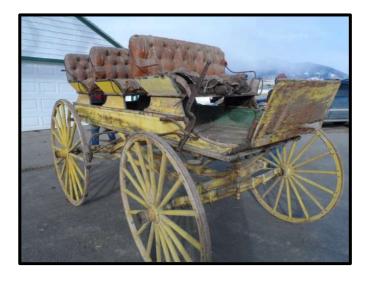
Records indicate this wagon was purchased and brought into Yellowstone National Park in 1915. It was used for one season before horses were banned from the park.

This wagon came to us in original condition retaining much of its original paint and pinstriping. All three bottom seat cushions were missing. The top, stanchions, and all mounting hardware were also missing.

The left front corner of the main sill and brace of the body was rotted out along with the front spring block rendering it non-drivable. Our client wanted it kept as original as possible and to still be able to hitch his horses and drive it.

The corner was repaired by removing the body, coping new wood onto the front part of the sill, and replacing the entire front cross brace and spring block.

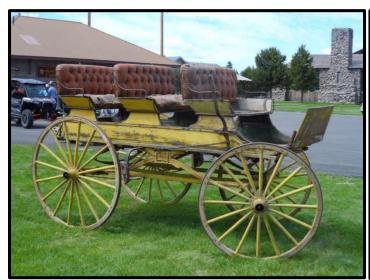
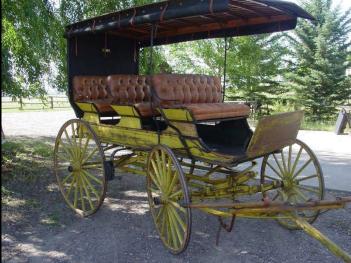
This wagon is a beautiful example of a Winona three-seat spring wagon with an interesting history.

The original seat backs were cleaned and patched. New seat bottom cushions were built.

An original top was found and purchased as a pattern and to procure the top stanchions. A new top was built along with a full set of side curtains.

The body attachments for the top had been removed. New pieces were 3D printed in metal from an original pattern.

The original paint was preserved with a thorough cleaning and a colored oil wash. New wood was patinaed and blended to match the original colors. One side of the driver's seat riser was weathered to the extent that it was blank wood, missing all its paint and color, while the other side retained some paint and the original numbers. Our friend Clyde Aspevig, a Montana artist, was able to reproduce the paint patina and numbers on the blank panel to match the existing original.
